How Efficient Are New Homes in California?

PIER Buildings Program

CEC-500-2011-TB-004
December 2011

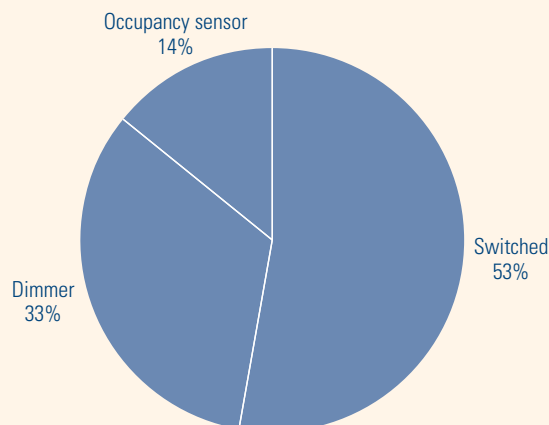
Figure 1: Lighting controls

Lighting. Although not violating existing Title 24 energy-efficiency standards, inefficient incandescent lighting was the most common light source—78 percent of the lighting wattage in single-family and townhouses was incandescent, while 12 to 13 percent was compact fluorescent. Apartment buildings had 68 percent incandescent bulbs and 20 percent compact fluorescent lamps (CFLs). Most of the lamp wattage was controlled by switches, with some dimmers and occupancy sensors (**Figure 1**).

Switching was the dominant form of lighting control. Multifamily units featured fewer dimmers and occupancy sensors than the single-family units shown here.
